# **Backside FIB/SEM analysis strategy to identify a new failure mode at an automotive magnetic sensor device**

M. Simon-Najasek<sup>1</sup>, S. Hübner<sup>1</sup>, M. Lejoyeux<sup>1</sup>, A. Lindner<sup>2</sup>, F. Altmann<sup>1</sup>

<sup>1</sup> Fraunhofer Institute for Microstructure of Materials and Systems IMWS, 06120 Halle

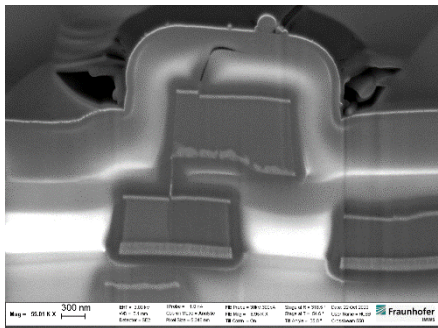
In this work we will demonstrate a failure root cause analysis of an automotive magnetic field sensor IC which fails by an electrical short between 2 metal layers, fig. 1. Over time a conductive path is created and at a certain resistance the devices fail with increased power consumption. This could be shown several times, but the question stays unanswered over a longer time regarding the primarily root cause. There are different hypotheses discussed, for example electrostatic discharge, package issues as well as imprints induced by probe tools.

by Ga-FIB at several positions and investigated by passive voltage contrast to identify the shorted part, fig. 3. Finally, the remaining shorted metal lines were screened by forwarding FIB cross sectioning under SEM observation till irregularities (delamination, cracks) could be found in the IC structure. The defect origin could be identified due to the preserved mould compound on top of the IC. A large filler particle touches the IC passivation at the position of the cracks. Due to the mechanical stress during the moulding process these cracks were initiated, later metal was migrating into these cracks forming an electrically conductive path between metal 1 and 2, fig. 4. The same failure mode could be verified at several sensor devices.

Fig. 1: SEM image of a FIB cross-section showing shorted metal lines due to a metal filled crack in-between these lines

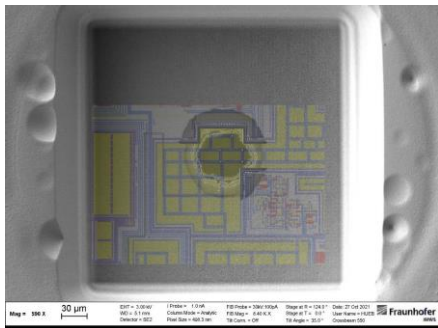
To get access to the ROI the Si substrate was mechanically thinned down to around 30µm thickness. After this the remaining silicon was removed by Xe-Plasma FIB trenching down to the active IC structure, fig. 2. Then the metal network was cut

Fig. 2: P-FIB backside trenching of the Si substrate overlaid with the IC layout of the ROI, before and after detailed Ga-FIB investigation
